## 4. Structural Systems Performance

*The dominant causes of structural failure observed by the MAT included storm surge, waves, floodborne debris, and wind. Structural damage due to erosion was also common on the barrier islands. Damage occurred to residential buildings (single- and multi-family housing), commercial buildings, and critical and essential facilities.*

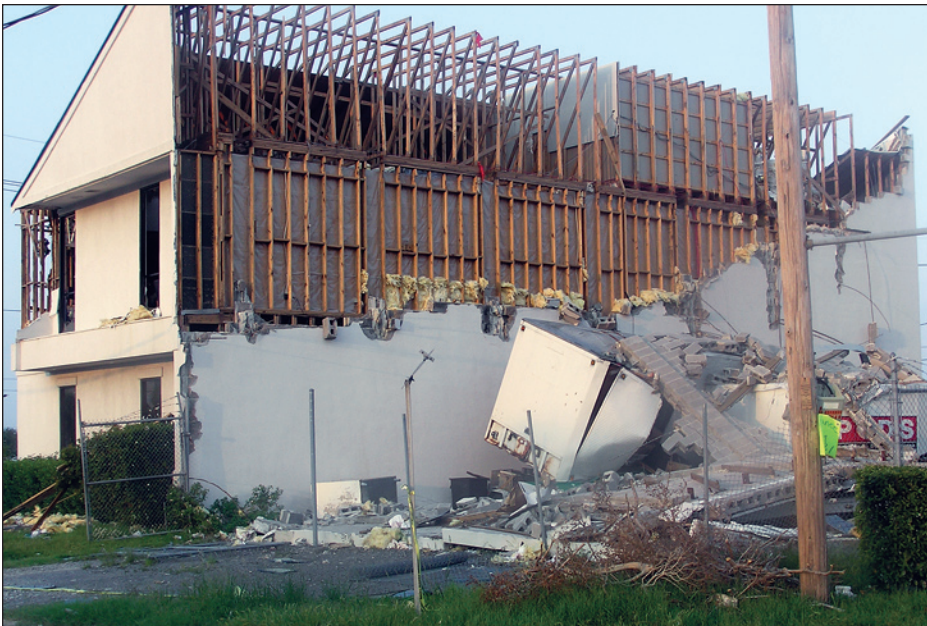
Wood-framed commercial buildings failed similarly to wood-framed residential buildings. Roof structure uplift failures and gable wall end failures like the ones shown in Figures 4-107 through 4-109 were observed. In Figure 4-109, the bottom chords of the roof trusses appear to have buckled under uplift forces. Insufficient truss bracing is suspected.

Figure 4-109.  
Three-story wood-framed  
commercial building lost  
roof sheathing and the  
exterior wall collapsed  
(estimated wind speed:  
105 mph. New Orleans,  
Louisiana)

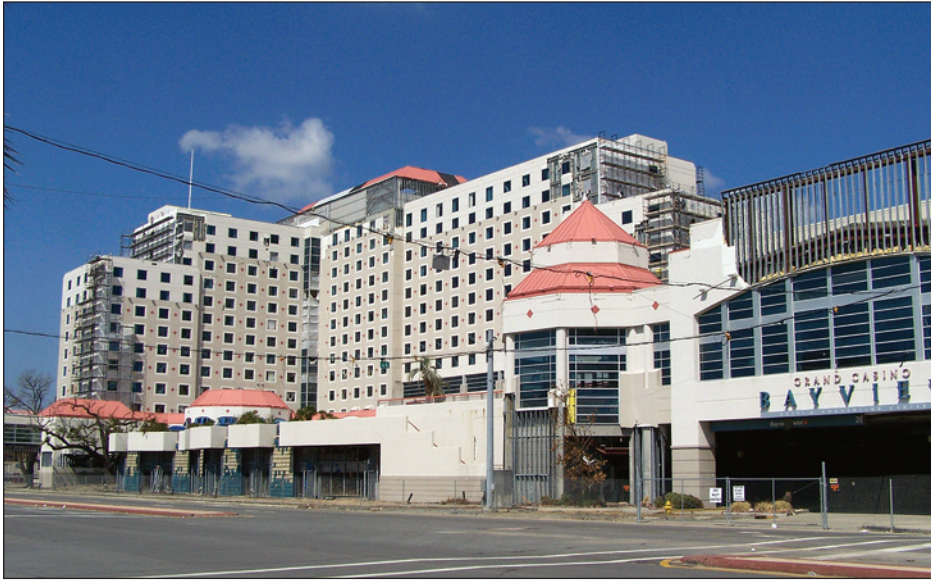
**Figure 4-110.**  
This casino located in Exposure C suffered water inundation and wind damage to wall finishes (estimated wind speed: 120 mph. Biloxi, Mississippi).

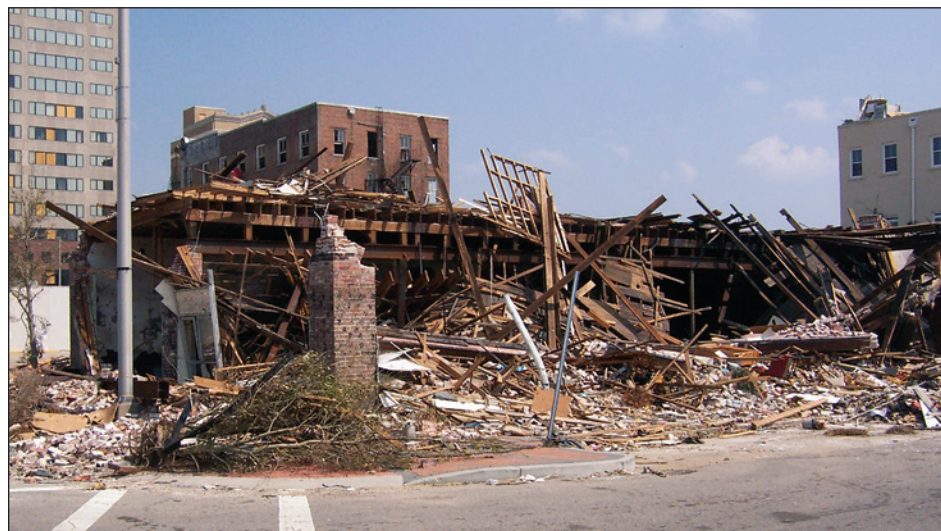
Other failure modes were observed in unreinforced masonry construction. In Figure 4-114, the parapet failed and visibly rotated toward the center of the building. The parapet portion of the wall acts as a cantilever above the roof structure. In this structure, the roof side of the parapet was exposed to the relatively high eave zone wind pressures and to bending moments. With no reinforcing steel present, the parapet failed in bending. Like other failures in unreinforced masonry, this type of failure is well known and is easily avoided with better construction measures.

Figure 4-114.  
Unreinforced masonry  
parapet failure on a  
building located in  
Exposure C (estimated  
wind speed: 130 mph.  
Gulfport, Mississippi)

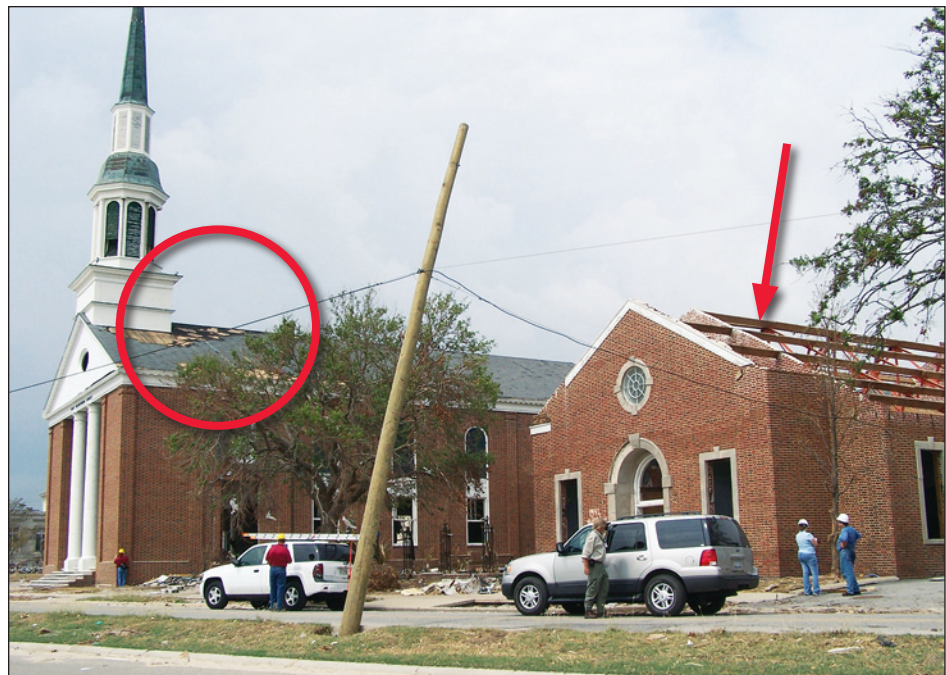
awning. The First Presbyterian Church of Gulfport, Mississippi (see Figures 4-117 and 4-118) was constructed of grouted multi-wythe brick masonry. Though the chapel lost its roof covering and decking, the heavy timber purlins and steel trusses remained firmly attached to the load-bearing masonry walls.

Figure 4-118.  
Grouted multi-wythe  
masonry walls. Note  
loss of roof decking  
(estimated wind speed:  
130 mph. Gulfport,  
Mississippi).

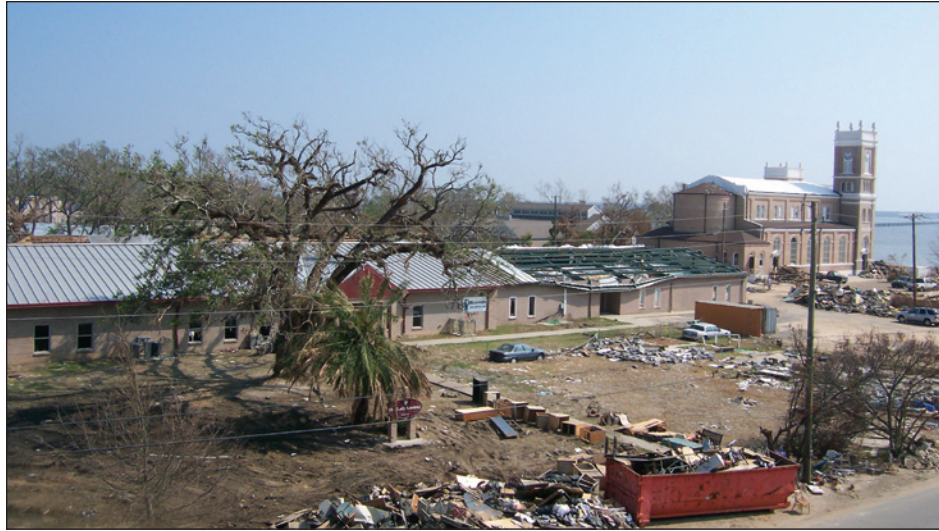
**Figure 4-120.**  
Undamaged newer PEMB constructed in 2001 (estimated wind speed: 130 mph. Pass Christian, Mississippi)

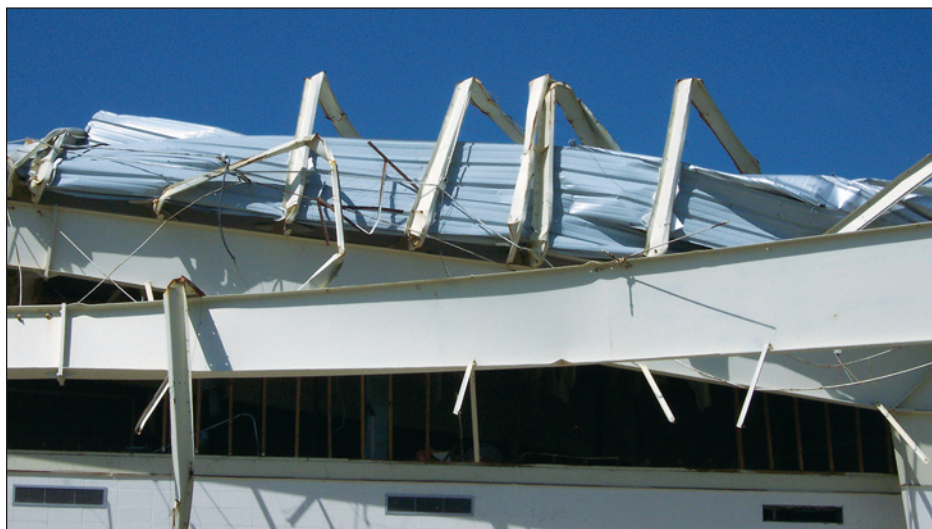
Most failures either involved connections between the metal roof panels and their supporting purlins, or between the purlins and the steel moment frames, as shown in Figures 4-122 through 4-125. Connection failures between the base of the moment frames and supporting footings were observed, but were much less common than connection failures higher up in the structure (Figure 4-124).

**Figure 4-123.**  
Connection failures  
between roof panels  
and purlins and between  
purlins and rigid frames  
(estimated wind speed:  
130 mph. Gulfport,  
Mississippi)

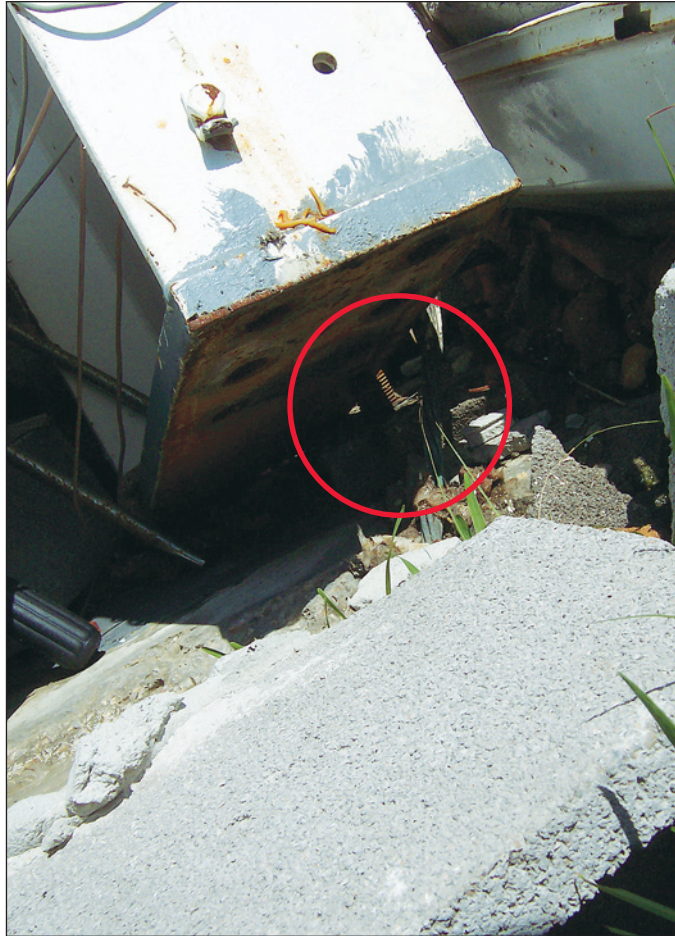
Figure 4-124.

Anchor bolt connection failure between steel base plate of the pre-engineered metal building frame and foundation (estimated wind speed: 130 mph. Gulfport, Mississippi)

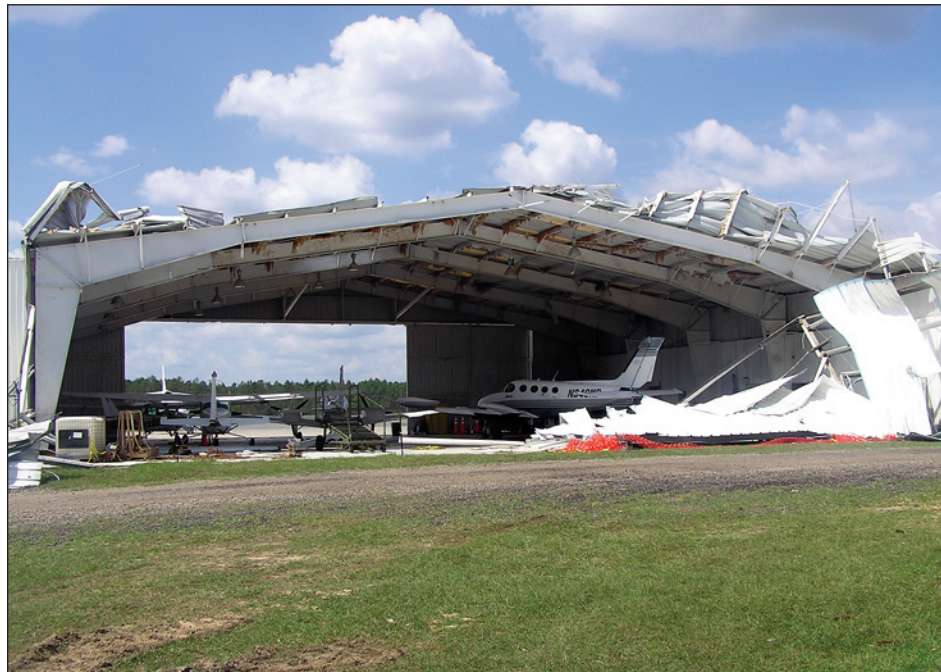
Figure 4-125.

Wall and roof covering failure in pre-engineered metal building. Moment frames not visibly damaged (estimated wind speed: 125 mph. Stennis Airport, Hancock County, Mississippi).

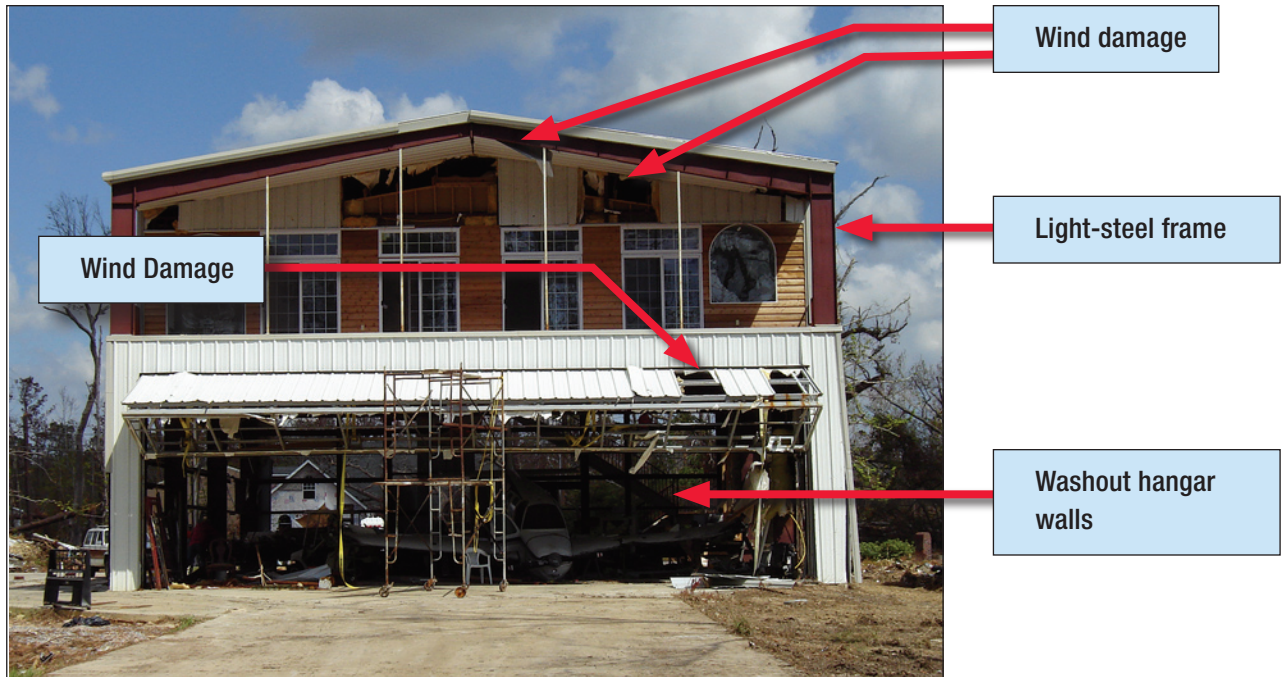
Figure 4-126.

Though not a commercial-use structure, the airplane hangar with a second floor residence was constructed of a light steel pre-engineered frame (see Figure 4-126). This home/hangar, along with others in the Diamondhead, Mississippi, fly-in residential community, was devastated by wind and water.

Residence/hangar constructed of a light-steel pre-engineered frame (estimated wind speed: 120 mph.  
Diamondhead, Mississippi)
